DEPARTMENT OF TRANSPORTATION

Quality Assurance and Source Inspection

Contract #: 04-0120F4Cty: SF/ALA Rte: 80 PM: 13.2/13.9File #: 99.28**WELDING INSPECTION REPORT****Resident Engineer:**Siegenthaler, Peter**Address:** 333 Burma Road**City:** Oakland, CA 94607**Report No:** WIR-017409**Date Inspected:** 09-Oct-2010**Project Name:** SAS Superstructure**OSM Arrival Time:** 700**Prime Contractor:** American Bridge/Fluor Enterprises, a JV**OSM Departure Time:** 1900**Contractor:** Zhenhua Port Machinery Company, Ltd (ZPMC) Chanxing Island**Location:** Shanghai, China**CWI Name:** Mr. Xu Tao**CWI Present:** Yes No**Inspected CWI report:** Yes No N/A**Rod Oven in Use:** Yes No N/A**Electrode to specification:** Yes No N/A**Weld Procedures Followed:** Yes No N/A**Qualified Welders:** Yes No N/A**Verified Joint Fit-up:** Yes No N/A**Approved Drawings:** Yes No N/A**Approved WPS:** Yes No N/A**Delayed / Cancelled:** Yes No N/A**Bridge No:** 34-0006**Component:** OBG Segment & Bike Path**Summary of Items Observed:**

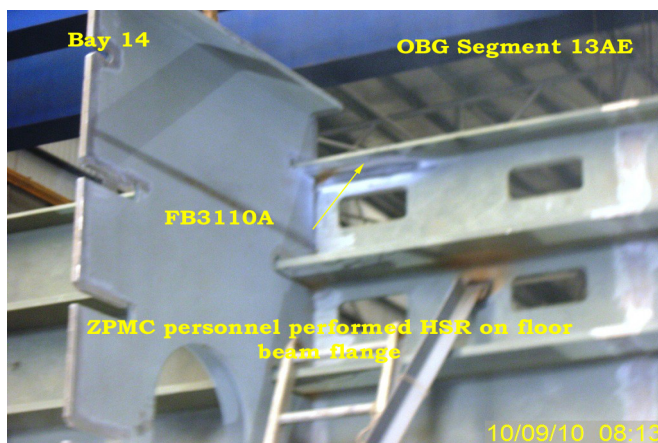
Description of Incident: During the Quality Assurance random work in progress and visual testing (VT) review of weld located on OBG Segment 13AE, this Quality Assurance Inspector (QA) observed that ZPMC personnel performing overhead crane to position plate SA3017B in position adjacent to floor beam FB3110A. This QA Inspector observed the top "T" flange of FB3110A appears to be distorted and the top "T" flange would not fit into the upper slot cut into SA3017B. ZPMC appears to have previously heat straightened the top "T" flange of floor beam FB3110A where the slot of plate SA3017A fits over the upper top "T" flange. ZPMC personnel heat straightening OBG Segment 13AW member identified as FB3110A. Distortion appeared to be caused by mishandling/Storage of the material. ZPMC Quality Control (QC) inspector identified as Mr. Geng Wei was present to monitor the heat straightening process. The heat straightening appeared to comply with HSR1 (B) number 9375. See the attached pictures.

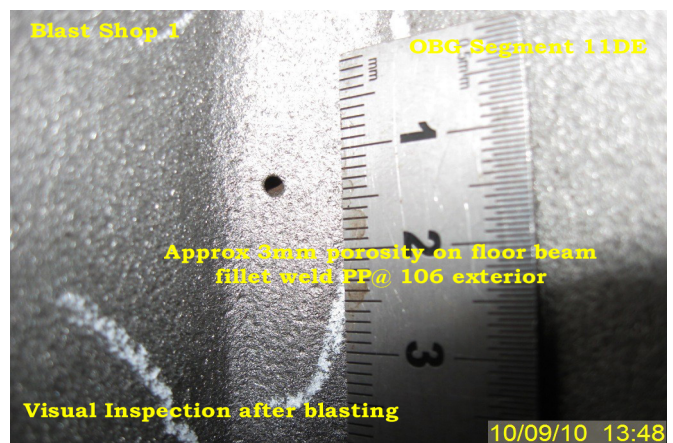
OBG Segment 11DE

This QA Inspector performed a preliminary random visual inspection on OBG Segment 11DE, after the grit blast of the exterior components of the deck panel, floor beams and corner assemblies of this segment. Areas of visual weld defects that will require welding were taped and will be repaired after the coating is applied. ZPMC QC personnel are aware of these areas and were present during the inspection. See the attached picture.
